Identification of issues for industry attention within Auckland building activities

May 2016

Authored by Paul Taylor

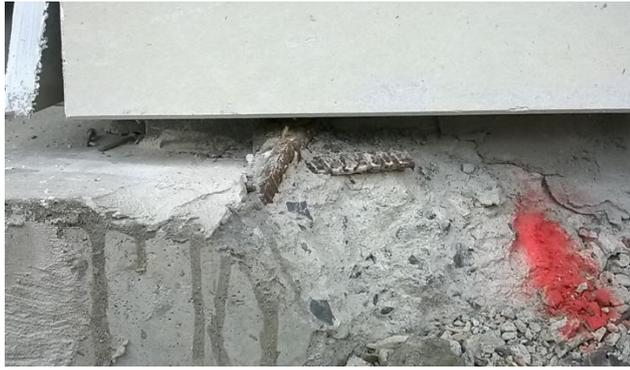
- Inability of designers to read contour plans resulting in the builder not being able to build as per the plan.
- Site specific failures because of poor designs.
- More cut and fill happening because of higher density housing and utilisation of land on challenging sites.
- Builders not having the experience but taking on the task. This point was raised a couple of times where inspectors have observed Asian developers not using specialist sub trades but having their builders do the foundations and slabs.
- Not enough specialists available and a decrease in skill level.
- Non-compliance with minor variations and no documentation on site, especially engineer's observations.
- Common workmanship issues:
 - Steel not tied.
 - Loose debris in footings.
 - Incorrect or lack of steel placement.
 - Concrete block work not to an acceptable standard.

An example of workmanship not to an acceptable standard.

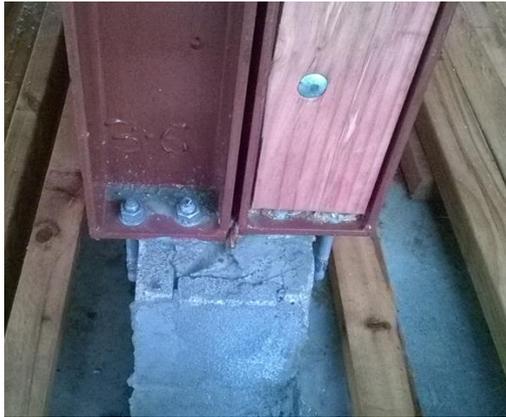
- Anchor bolts being used without washers (sold separately)
- Wind ties missed out at framing especially top plate to stud (could this be done by the pre-nail manufacturer?)
- Structural connections shown in engineering details but not shown on the plan therefore missed by the builder.

Poor design and workmanship

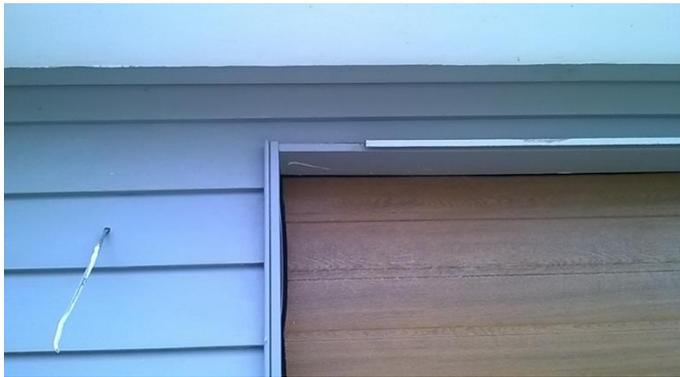
unsafe scaffolding. Comments from inspectors were around the detailing and installation of flashings and builders not reading plans or the product's technical literature. (See Building Products page 17)

Did the builder really think that the inspector wouldn't notice the flashing?
